Timbuktwo Generating Conglomerate

**Vibration Acceptance Report for
Unit 2 Boiler Feed Pump & Motor**

*Submitted on
January 19th 2015*

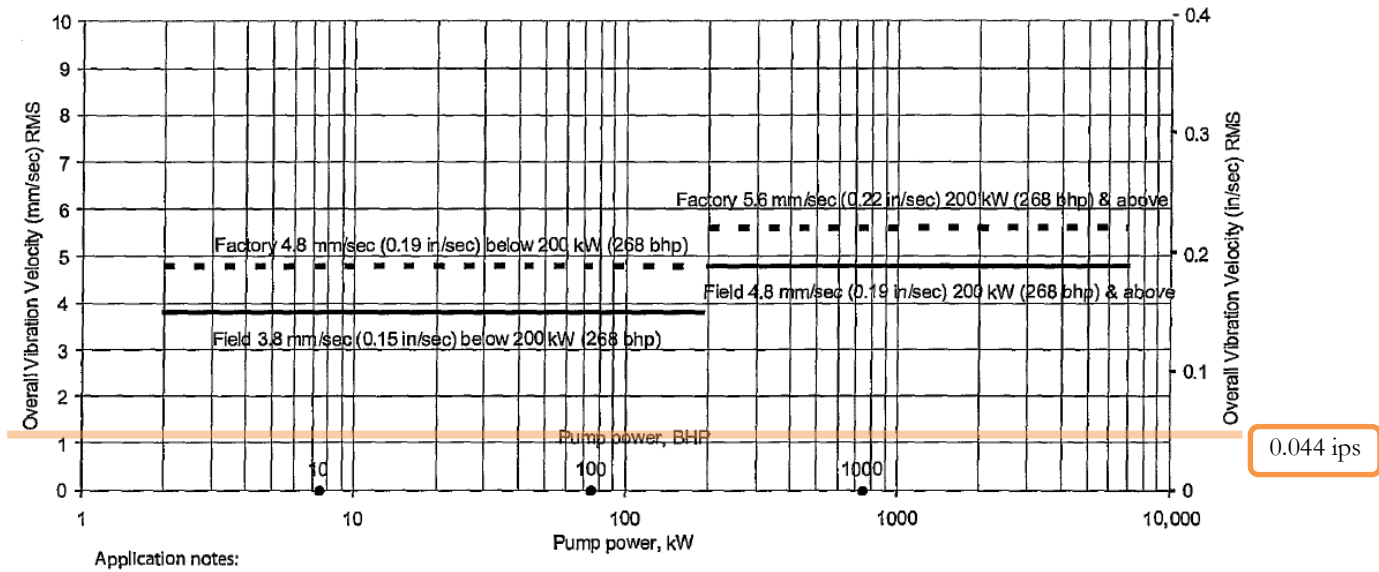
The highest overall level recorded was at the drive end vertical of the pump. It was 0.0437 ips which is less than half of the acceptable overall level specified in the ANSI 2009 standard.

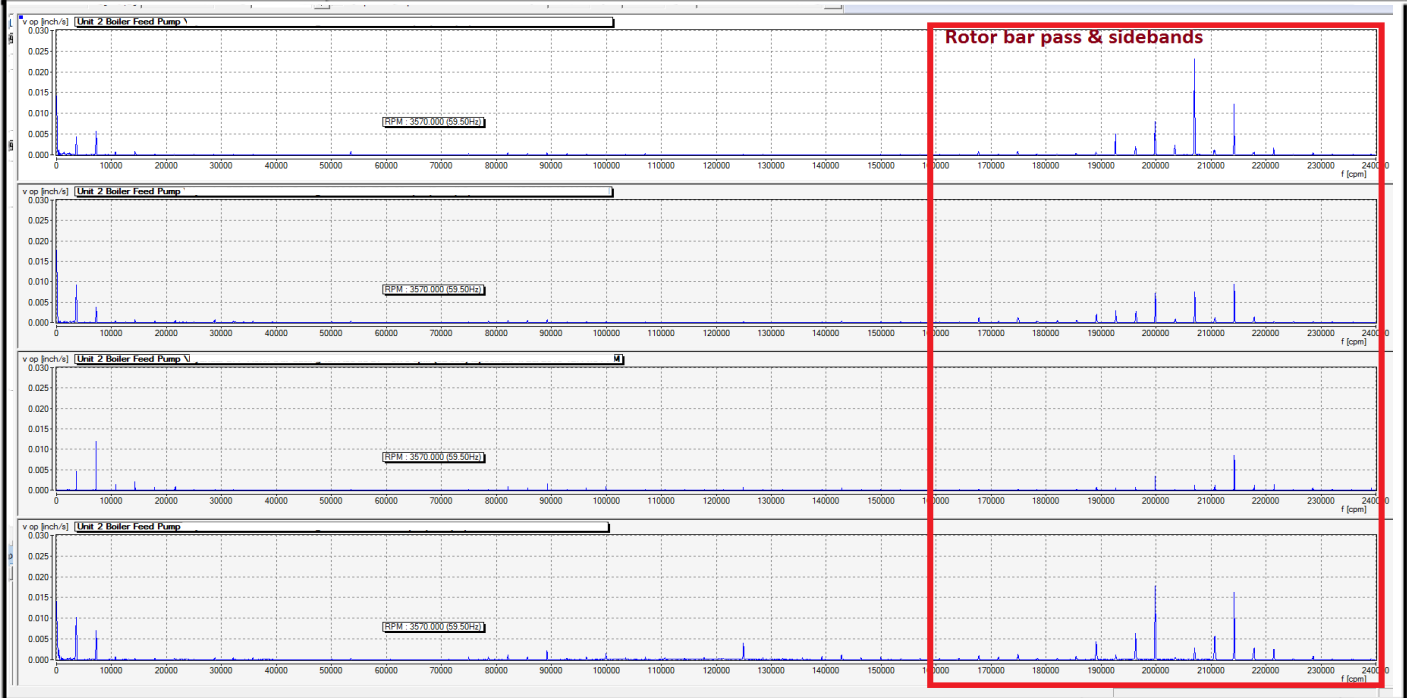
Description
The vibration amplitude is normal on this motor. Condition should be monitored to identify defects in their earliest stages so they can be corrected before costly failure.

Name	Description
1/2015 Mtr Radial	All amplitudes are acceptable. Trend RBP (rotor bar pass) to monitor health

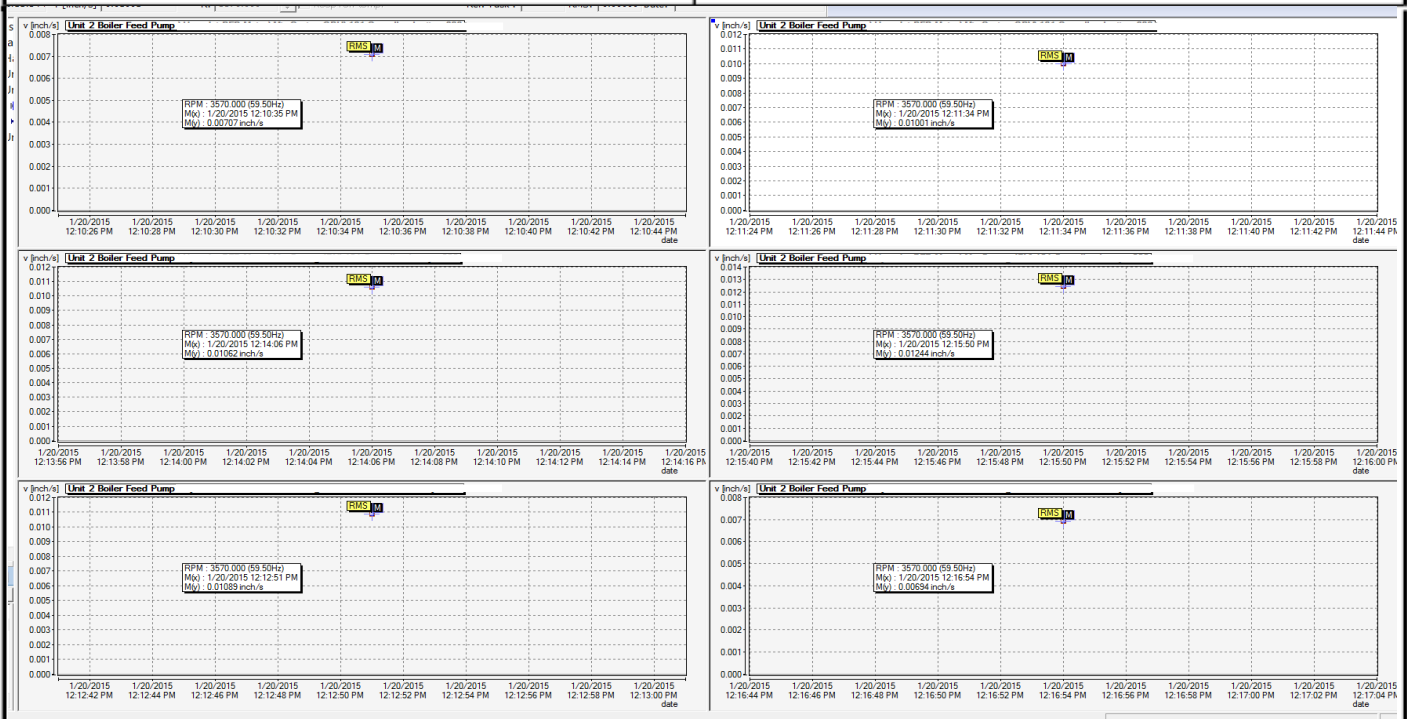
Name	Description
1/2015 Mtr RMS OAs	Motor RMS Overall

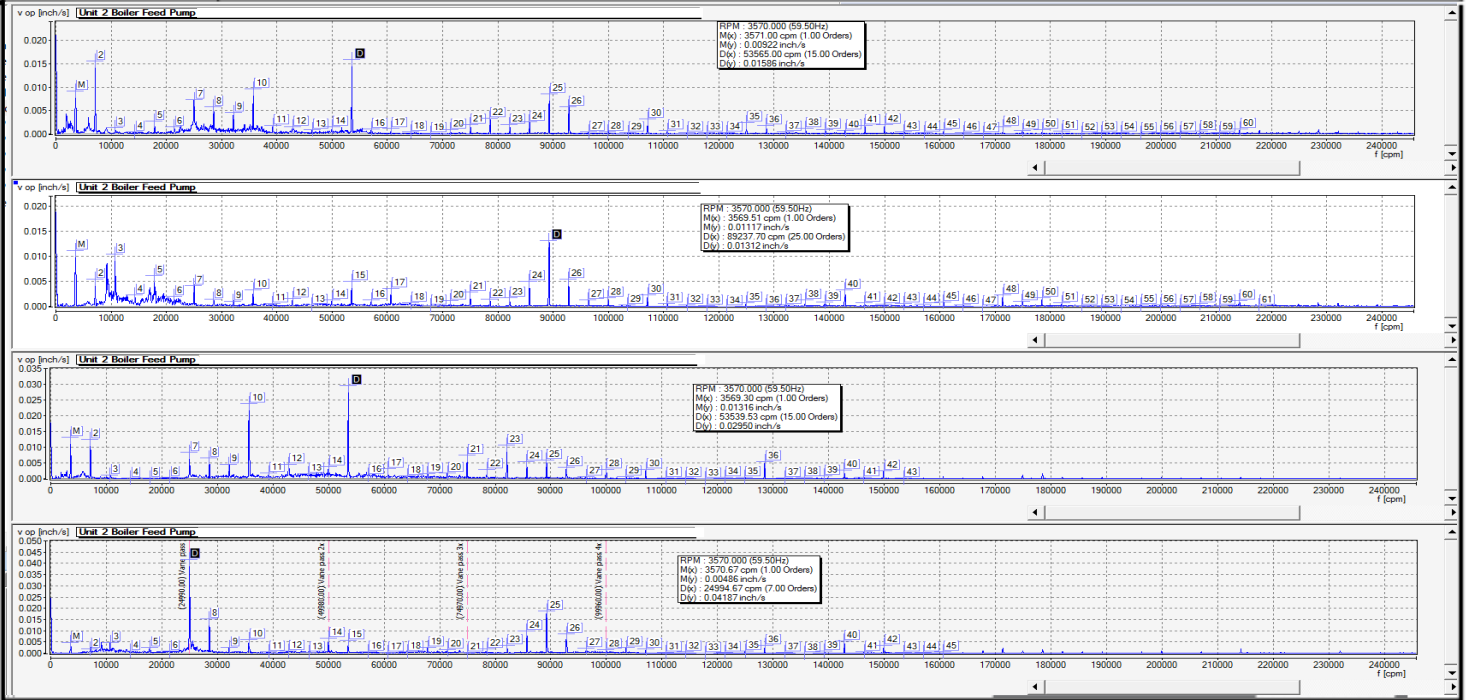
Description
Pump vibration levels are normal. Monitor for developing defects.

Name	Description
1/2015 Pump Radials	Amplitudes acceptable. All peaks appear run speed harmonics. Pump stages 5 and 7 vane. There are 2x harmonics that need to be watched.

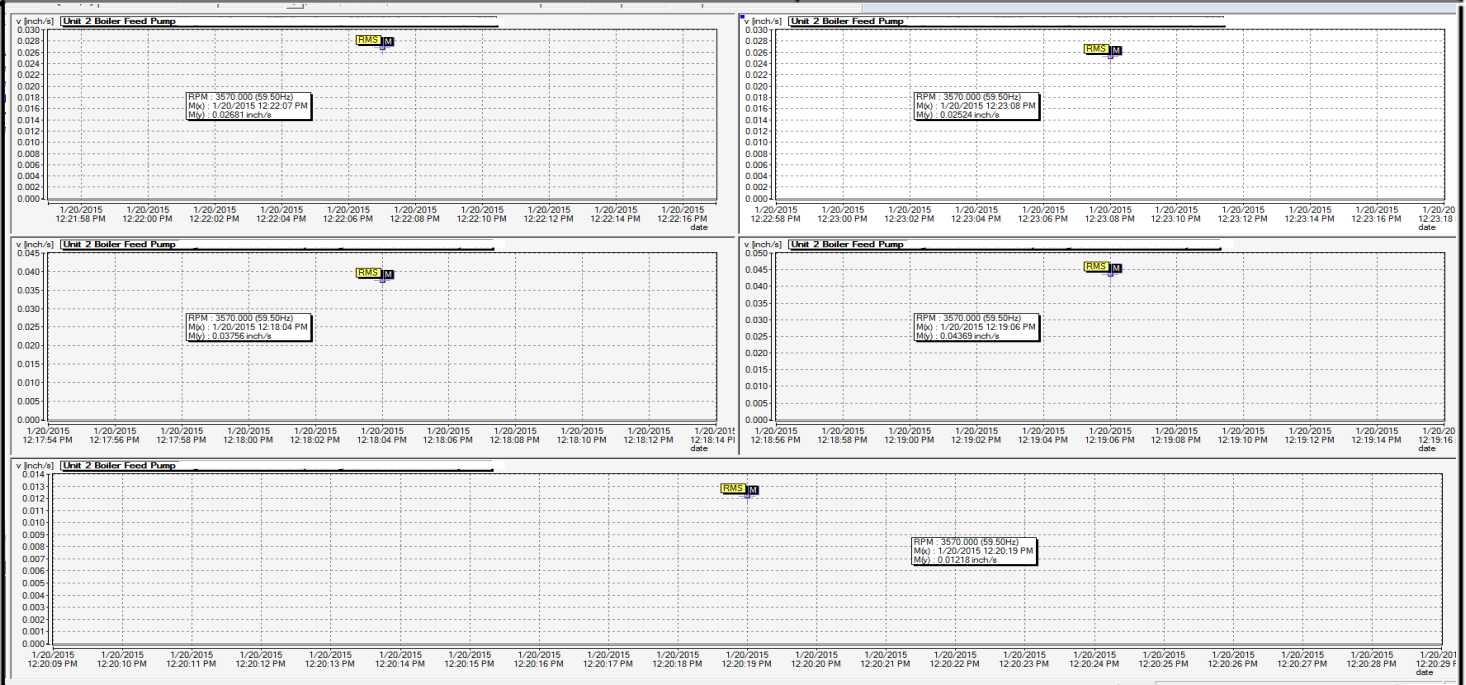
Name	Description
1/2015 Pmp RMS OAs	Pump RMS OAs
